秋野蒔絵硯箱：修復報告書：在外日本古美術品保存修復協力事業：No.2013-1

秋野蒔絵硯箱
*Suzuribako with design
of an autumn field in maki-e*

ブロッツワフ国立博物館（ポーランド共和国）
漆工品

No.2013-1

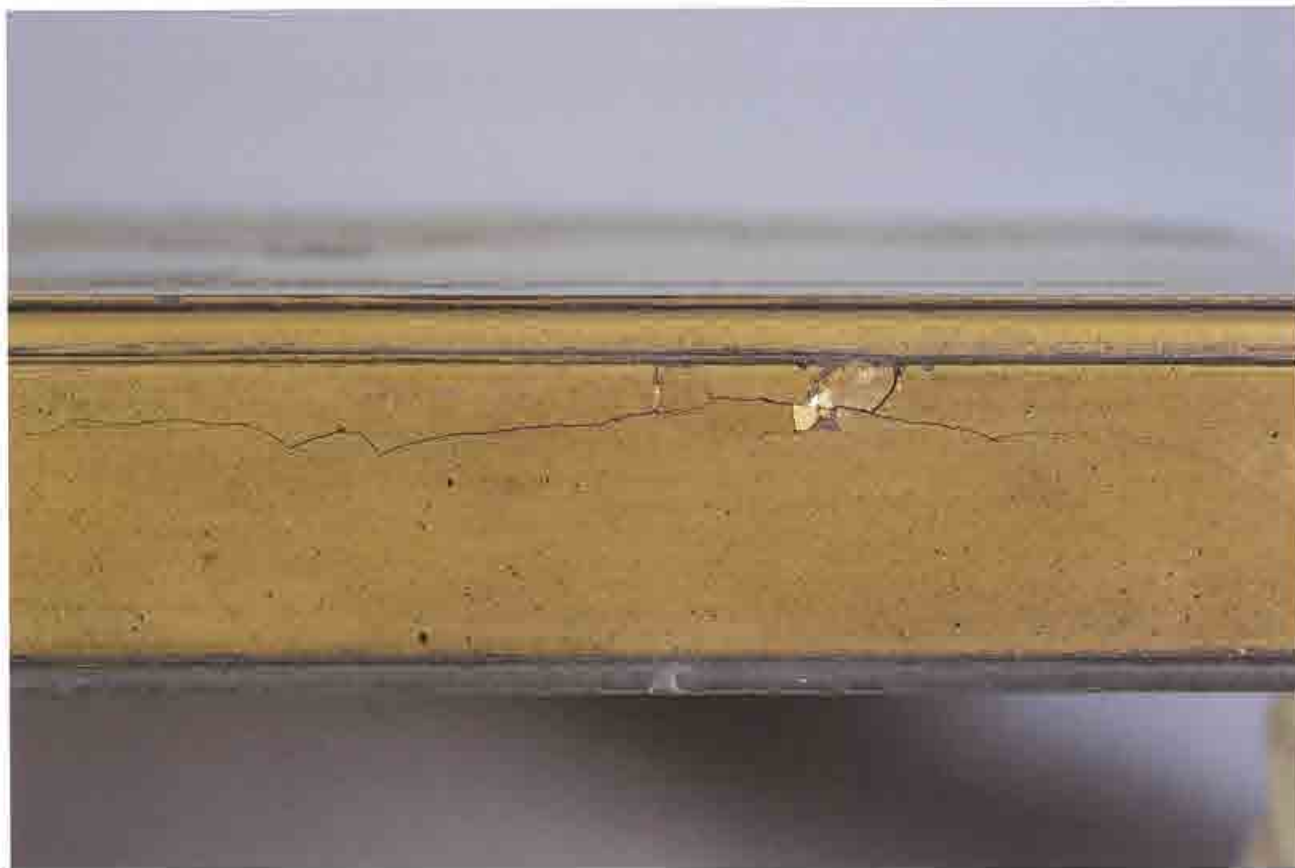
- ・全体に細かい打損が多く入っていた。蓋甲板では月の下に楕円形の打損が認められた。
- ・懸子は打損により木地が数ミリまで鋭角に沈み、木地が露出していた。
- ・背面の蓋蔓では打損により金地が大きく凹み、複数の断片に分かれて周囲に剥離が広がっていた (Fig. 1.7 (a))。

- There were many traces of the object having been damaged because of physical impact. There was a trace of an oval-shaped damage caused by physical impact below the moon on the upper face of the lid.
- Parts of the inner tray had dented severely to a depth of several millimeters, causing the substrate to become exposed.
- The *kinji* on the side of the lid at the back had also dented largely causing it to separated into several fragments. This had led to further exfoliation in the surrounding parts (Fig. 1.7 (a)).

Fig. 1.7 蓋蔓背面の打損 (a)修復前
Damage due to impact on the edge of the lid at the back (a) before restoration

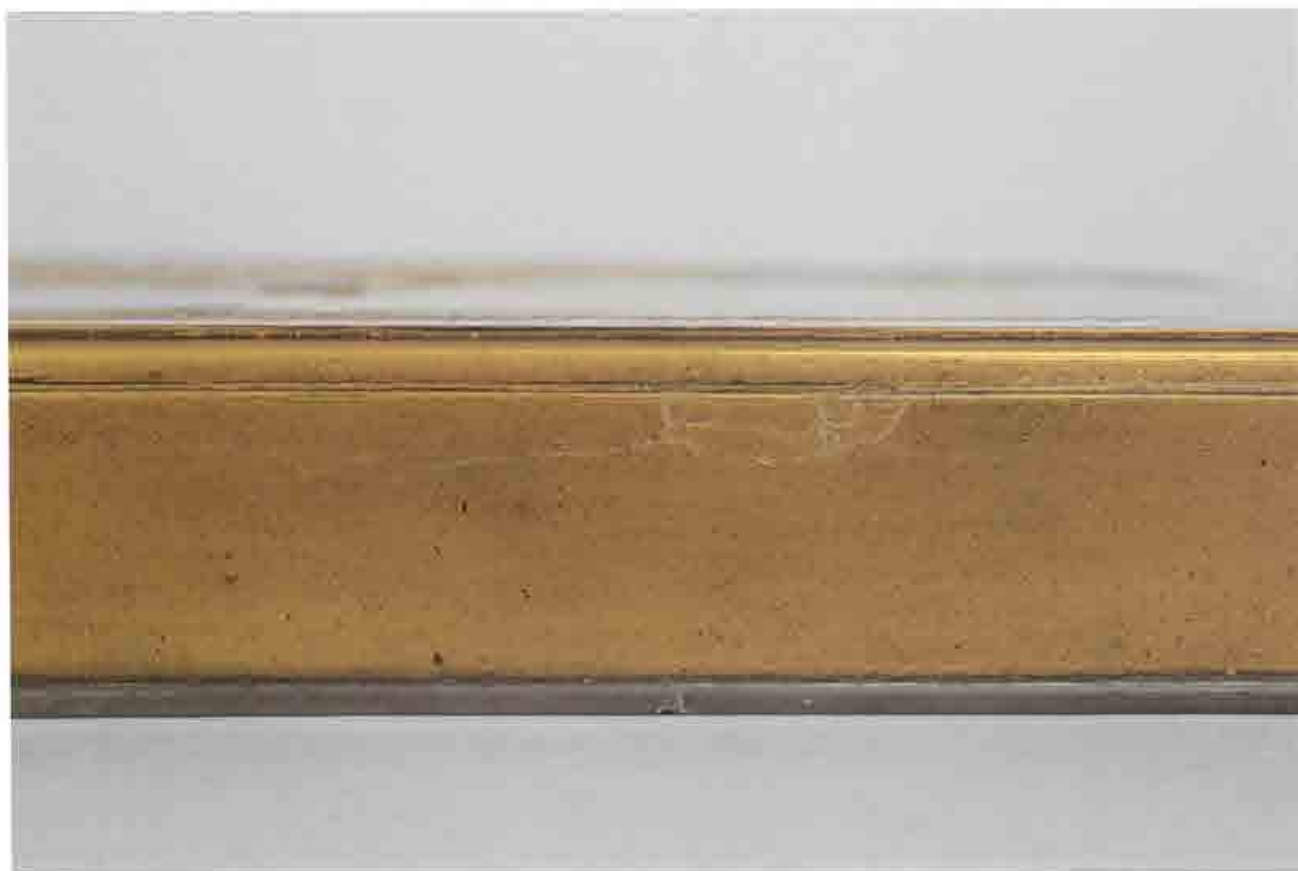
Fig. 1.7 蓋蔓背面の打損 (b)修復後
Damage due to impact on the edge of the lid at the back (b) after restoration

蓋裏背面の打損箇所は取り外した断片下に木の損傷が認められた。木地凹部に刻苧（麦漆＋蝦夷松木粉）を木地表面の高さまで充填した。懸子打損箇所は漆塗膜が大きく凹んでおり、損傷は木地にまで及んでいたため漆塗膜を取り出すことはできないと判断した。そこで、打損部に残る漆塗膜を保護するために楮紙をフノリで塗膜表面に貼り込んだ。次に抹香漆（水練抹香1:0.04 生正味漆）で凹部に充填した。

形状修正した蒔絵断片を確認し、麦漆と柔らかく調整した刻苧を用いて本来の位置に再接着した。再接着するにあたって金地表面が平滑になるように努めた。蒔絵表面はアクリル板とサランラップ、裏面はシナ合板、黒ゴム板とサランラップを組み合わせた板をクランプと端金で抑えた。余分な漆はリグロインで拭き取り、十分乾燥させた。

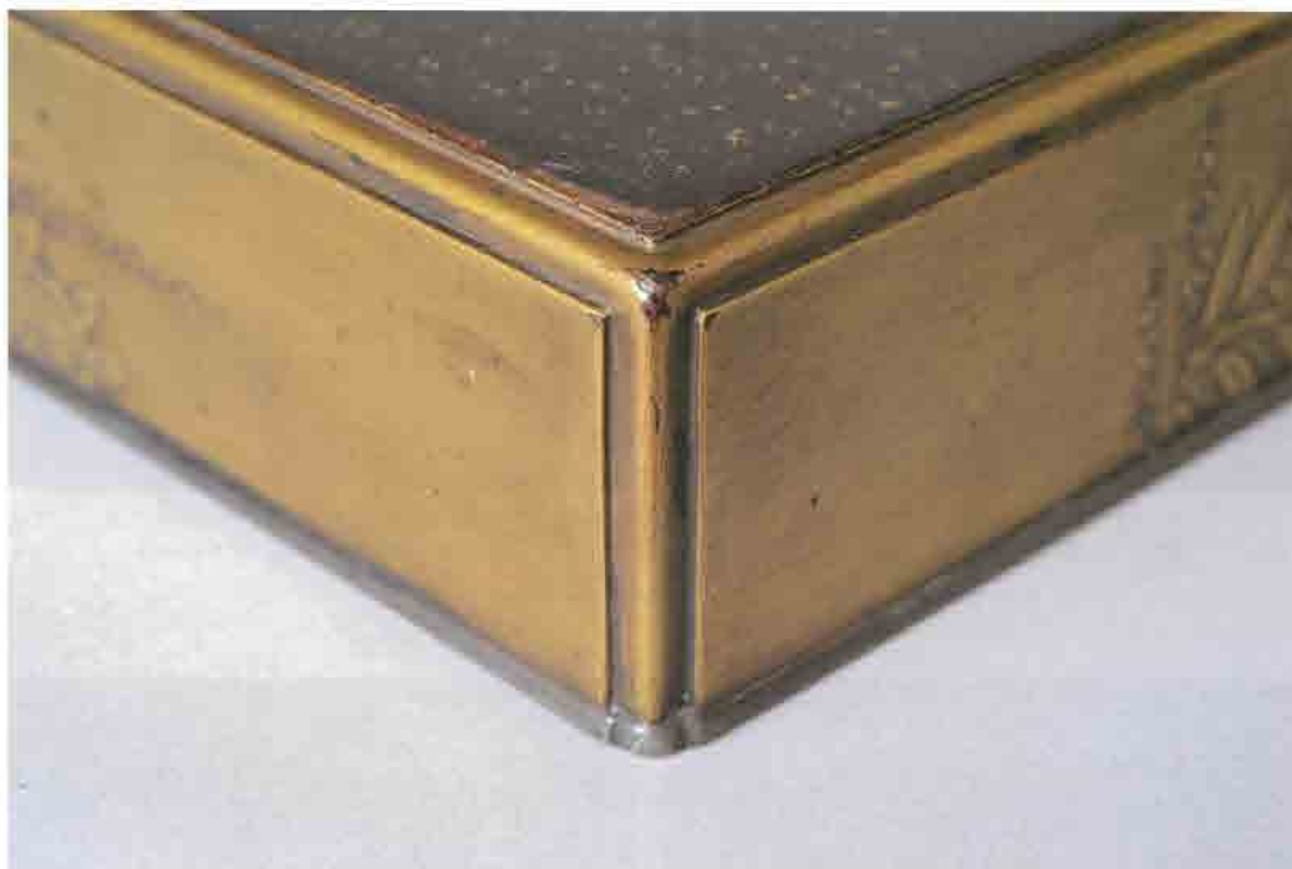
- ・桔梗花の螺鈿は一部で亀裂が入るだけでなく、多くの部分で剥離し、一部は欠失していた。
- ・蓋裏に素地の亀裂が認められ、素地が剥ぎ合わされた部分近くに蜘蛛状に広がっていた。
- ・身の二隅に亀裂が入り、一部で下地と金地が欠失していた (Fig. 1.8 (a))。
- ・硯の下部に亀裂が認められた。

- The *raden* of the bellflowers had not only cracked in parts but had also exfoliated at many places. Some were missing.
- Cracking of the substrate was found on the underside of the lid. Cracks had spread near the joints of the substrate in a spider web-like manner.
- There were cracks on two corners of the body, and the foundation and *kinji* were missing partially (Fig. 1.8 (a)).
- Cracking was observed on the lower part of the ink stone.

Fig. 1.8 身側板角の亀裂 (a)修復前
Crack on the corner of the side board of the body (a) before restoration

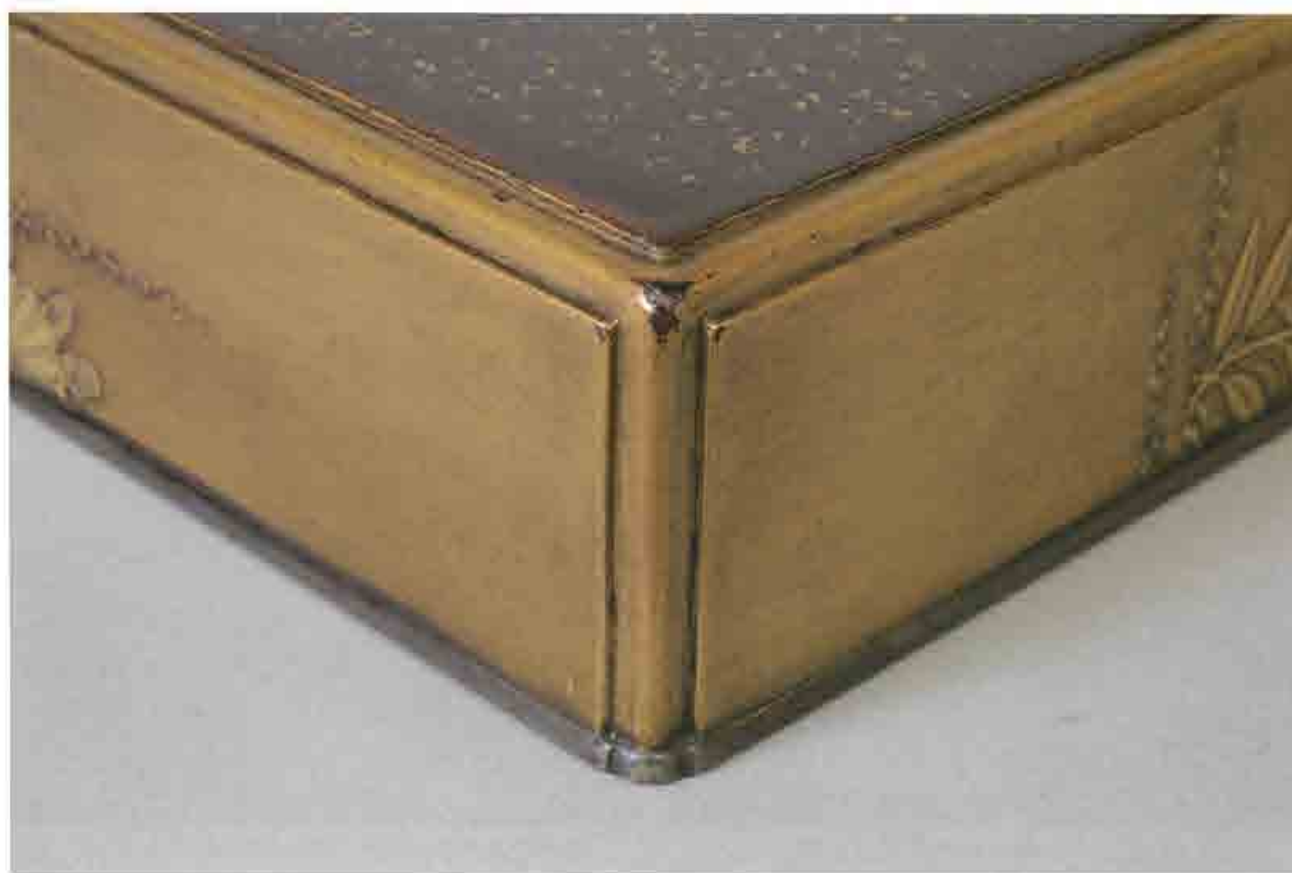
Fig. 1.8 身側板角の亀裂 (b)修復後
Crack on the corner of the side board of the body (b) after restoration

蓋裏木地の亀裂によってできた塗膜の亀裂部分にリグロインで希釈した接着用の麦漆を亀裂含浸した。身側板接合部の亀裂にも同様の麦漆を含浸し、端金で抑えた。硯下部の亀裂にも同様の麦漆を含浸しよく乾燥させた。

懸子打損部分は漆下地を施した後に黒名倉砥石で平滑に研ぎ、黒蠟色漆塗りの後に透漆を塗り込んだ。磨き工程（研ぎ、摺り、胴摺り、磨き、摺り）を行い漆表面の艶を周囲に合わせた。蓋裏打損部分と身側板亀裂部分には透漆に金延粉を練り込んだ金色下地を薄く付けて色調整を行った。

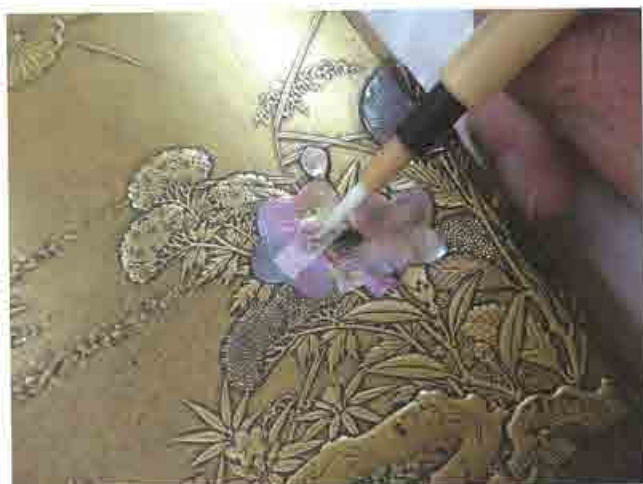
Fig. 1.9.1 養生
Facing

(3) 養生（Fig. 1.9.1）

蓋蔓背面の打損部分と螺鈿の剥離箇所に小片に切った雁皮紙を上新粉糊で貼った。

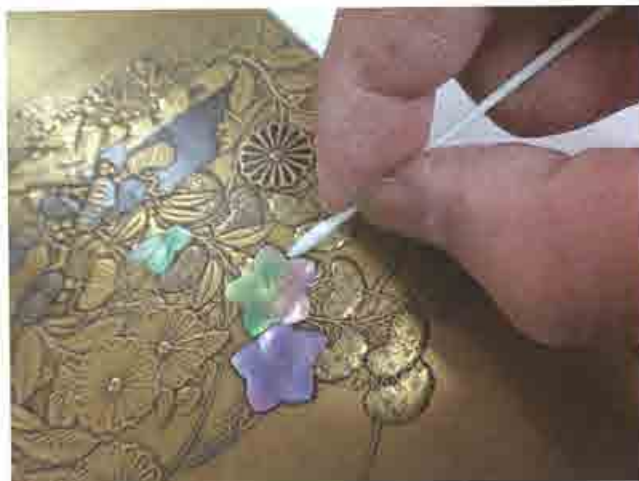
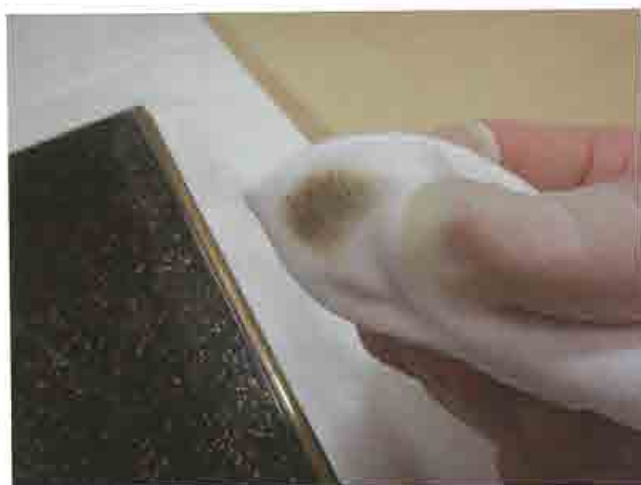
Fig. 1.9.2 クリーニング 1
Cleaning 1

Fig. 1.9.3 クリーニング 2
Cleaning 2

(5) クリーニング（Fig. 1.9.2、Fig. 1.9.3）

全体に被った埃を毛棒で払った。クリーニングテストの結果を受けて、全体のクリーニングには消毒用エタノール、高蒔絵際の付着物には消毒用エタノールとアセトンの他に蒸留水を併用することとした。クリーニングは溶剤等を僅かに綿布と綿棒に付けて行い、蒔絵際に溜まった付着物を出来る限り除去した。水滴など金具に付着した錆をエタノールで除去した。

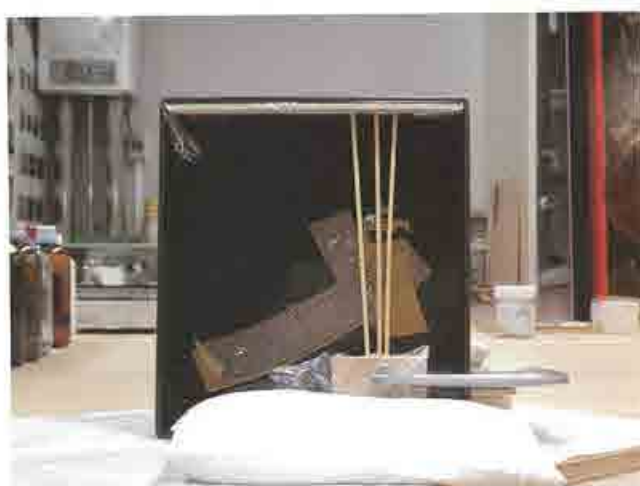
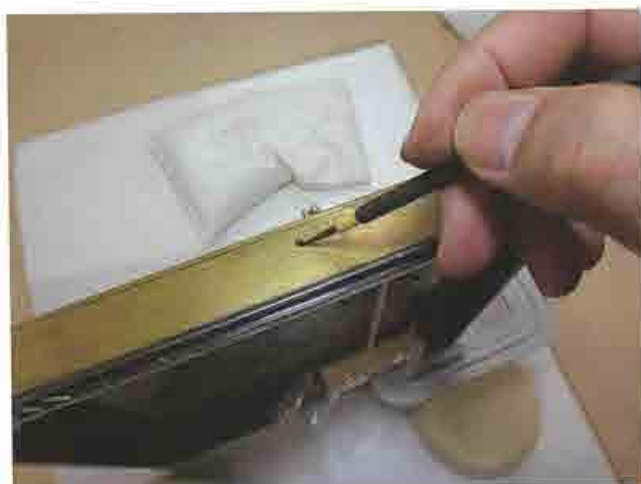
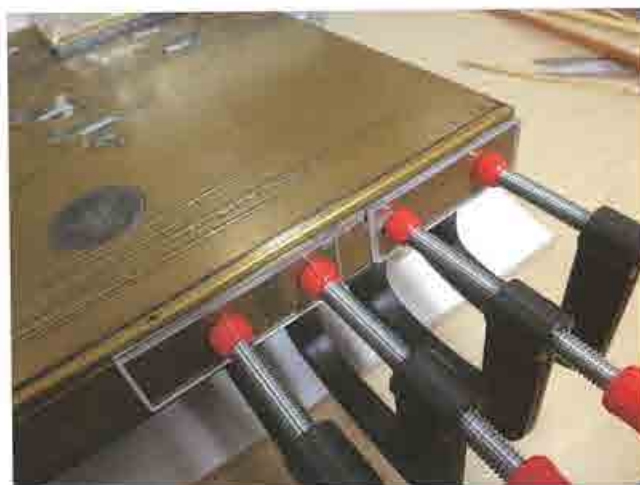
Fig. 1.9.4 蓋蔓の亀裂段差修正
Correcting the gap made by the crack
on the side of the lid

Fig. 1.9.5 亀裂部分の麦漆含浸
Impregnating *mugi-urushi* into a crack

Fig. 1.9.6 蓋蔓の亀裂接着
Adhering the crack on the side of the lid

(6) 蓋蔓の亀裂接着（Fig. 1.9.4、Fig. 1.9.5、Fig. 1.9.6）

蓋蔓背面の亀裂は僅かに上下に段差が出来ていたため、ラミン丸棒を対面の蓋蔓内側からプレスして段差を持ち上げた。亀裂部分にリグロインで希釈した接着用の麦漆を含浸し、蒔絵表面はアクリル板とサランラップ、裏面はシナ合板、黒ゴム板とサランラップを組み合わせた板をクランプで抑えた。余分な漆はリグロインで拭き取り、十分乾燥させた。

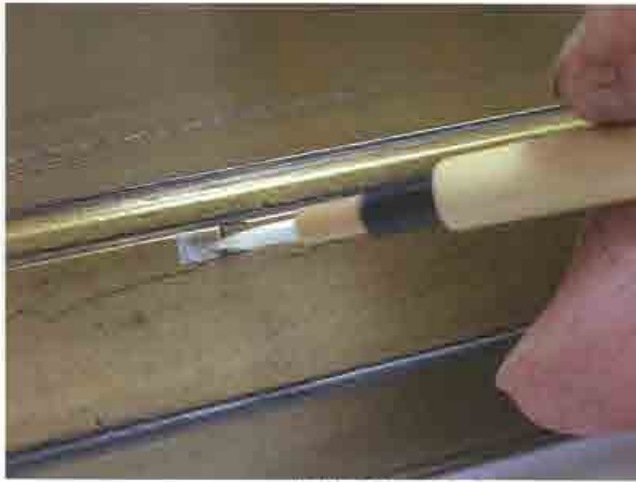
Fig. 1.9.7 蒔絵断片の養生
Facing the *maki-e* fragment

(7) 蒔絵断片の養生（Fig. 1.9.7）

打損部分に当初行った養生を取り外し、修復方法を検討した。その結果、蓋蔓背面部分で打損により金地が大きく凹んだ断片は一旦取り外すこととした。取り外し時に養生紙がはがれないようにするためポバール（PVAL 3500. 7.5%水溶液）を用い、レーヨン紙やポリエステル紙を併用して断片表面に接着した。

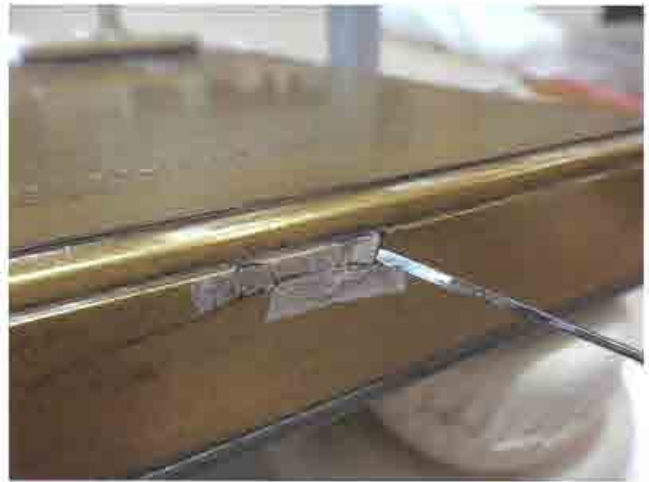
Fig. 1.9.8 蒔絵断片の取り外し
Removing the *maki-e* fragment

(8) 蒔絵断片の取り外し（Fig. 1.9.8）

歪んだ蒔絵断片の際に木綿針を加工した道具を差し込み、崩れないように断片を取り外した。断片は取り外すことは可能であったが、打損時の衝撃で細かい亀裂が入っていたことから亀裂部分の下地から崩れた。

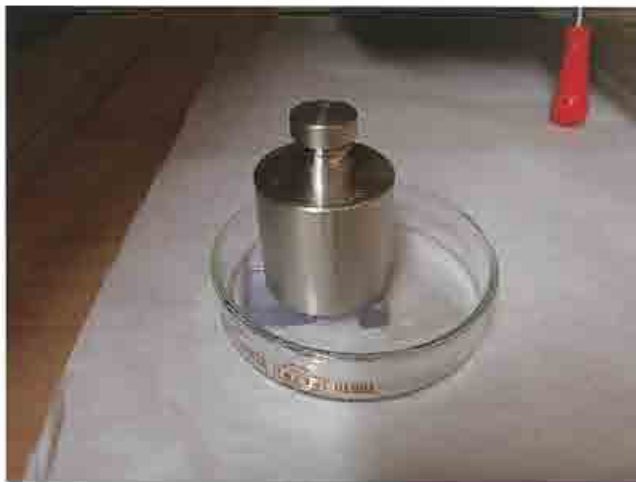
Fig. 1.9.9 蒔絵断片の形状修正
Correcting the shape of the *maki-e* fragment

(9) 蒔絵断片の形状修正（Fig. 1.9.9）

取り外した断片は歪んでいたため、形状修正を行った。取り出した断片をシャーレに伏せて入れ、アクリル板を被せて錘を置き、そのまま1か月間放置した。

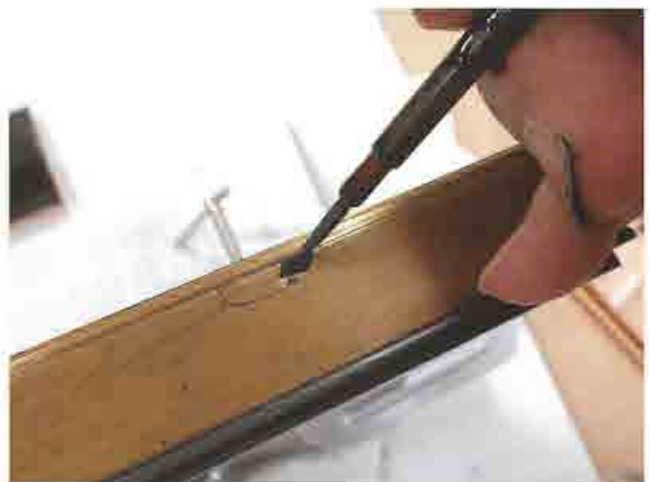
Fig. 1.9.10 漆塗膜の剥落止め
Consolidating the urushi coating film

(10) 漆塗膜の剥落止め (Fig. 1.9.10)

打損部周囲の剥離した漆塗膜にリグロインで希釈した接着用の麦漆を含浸し、蒔絵表面はアクリル板とサランラップ、裏面はシナ合板、黒ゴム板とサランラップを組み合わせた板をクランプで抑えた。余分な漆はリグロインで拭き取り、十分乾燥させた。

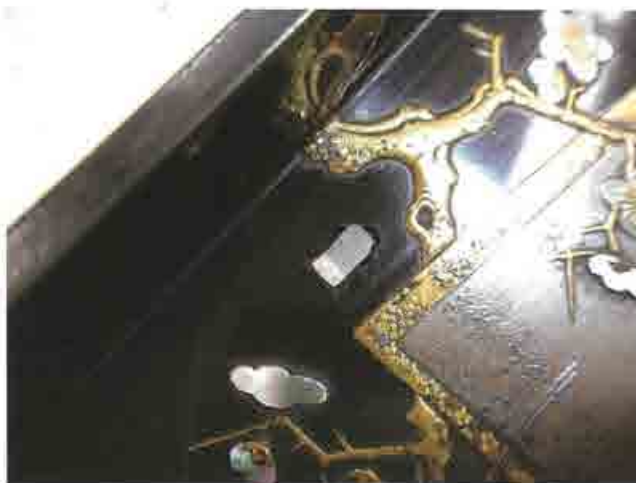
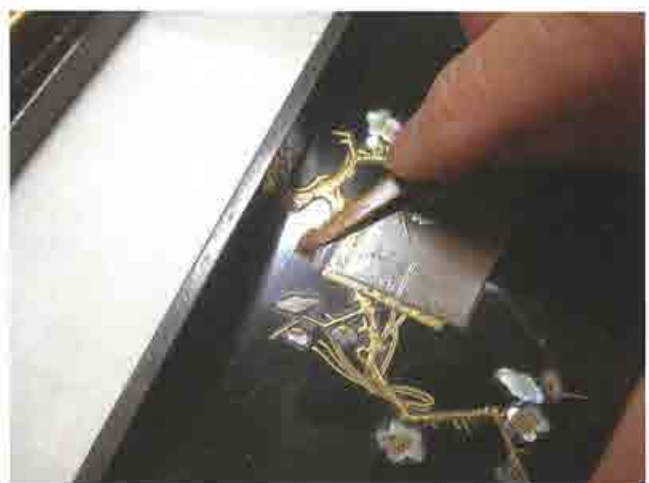
Fig. 1.9.11 打損箇所の充填 (楮紙による塗膜保護)
Filling the part damaged by impact (protecting the coating film with *kozo* paper)

Fig. 1.9.12 抹香漆による打損箇所の充填
Filling the part damaged by impact with a mixture of *makko* urushi

(11) 打損箇所への充填 (Fig. 1.9.11、Fig. 1.9.12)

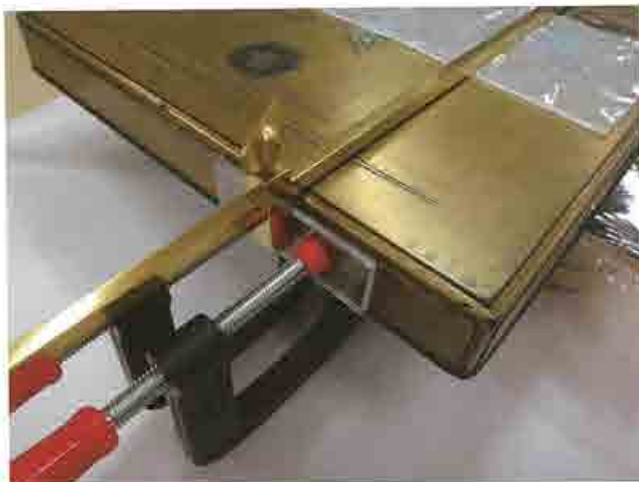
Fig. 1.9.13 蒔絵断片の貼り戻し
Re-attaching the *maki-e* fragment

(12) 蒔絵断片の貼り戻し (Fig. 1.9.13)

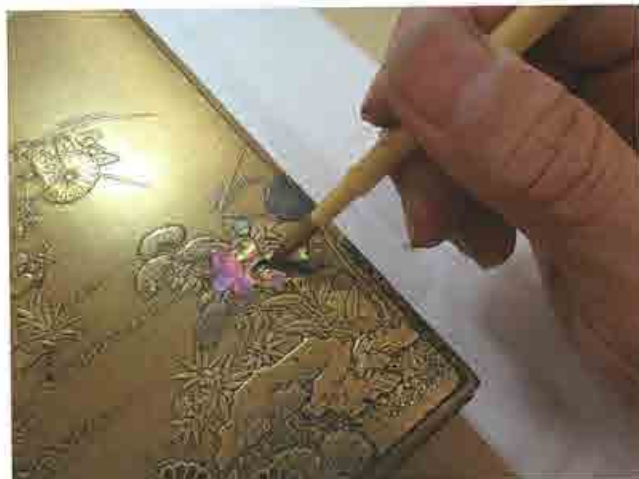
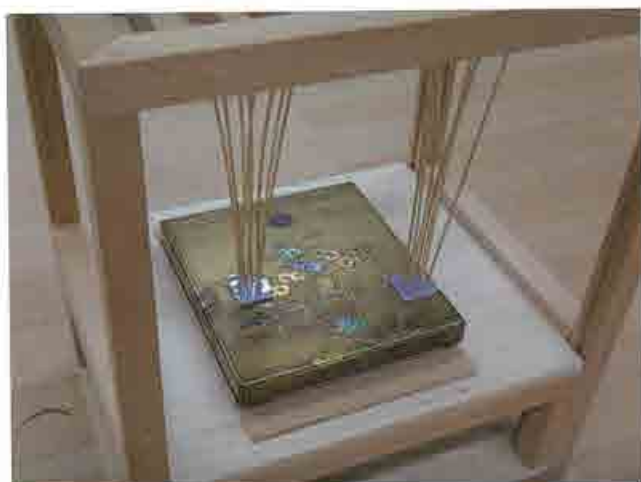
Fig. 1.9.14 螺鈿の剥落止め（膠水溶液の含浸）
Consolidating *raden* (impregnating aqueous
animal glue solution)

Fig. 1.9.15 木枠とラミン棒による螺鈿の剥落止め
Consolidating *raden* with a wooden frame and
ramin sticks

(13) 螺鈿の剥落止め (Fig. 1.9.14、Fig. 1.9.15)

剥離した螺鈿に膠水溶液（パールグルー15%）を含浸して余分な膠は蒸留水で拭き取った。膠が乾燥しないうちにシリコンとビニールシートを重ねた抑え板を剥離部分に当てて木杵とラミン棒を用いて圧着した。

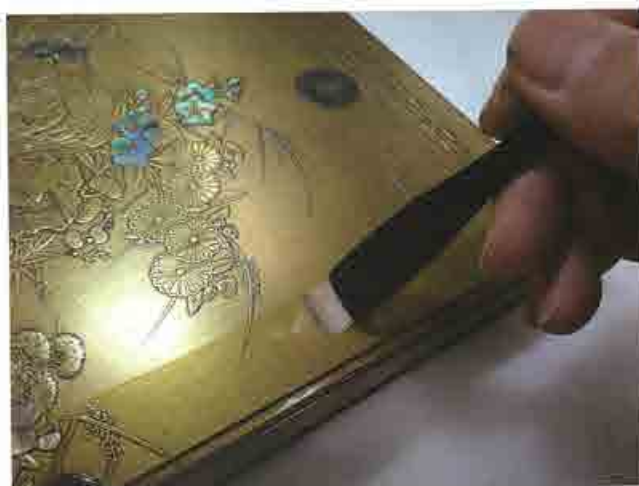
Fig. 1.9.16 蓋の漆固め
Consolidating *urushi* on the lid

(14) 漆固め (Fig. 1.9.16)

漆塗膜と蒔絵粉の強化のため漆固めを行った。硯箱全体の漆塗膜にはクリーンソルGで4～5倍に希釈した生正味漆を溜み刷毛で塗布し、リグロインで拭き取った。蒔絵表面にはクリーンソルGで4～5倍に希釈した透漆（生正味漆を2割程度混合）を溜み刷毛で塗布し、リグロインで拭き取った。漆固めは湿度を70%前後に調整した漆風呂で十分に乾燥させた。

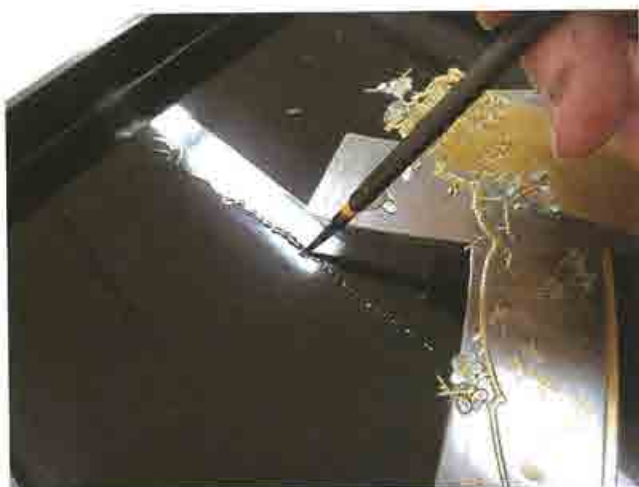
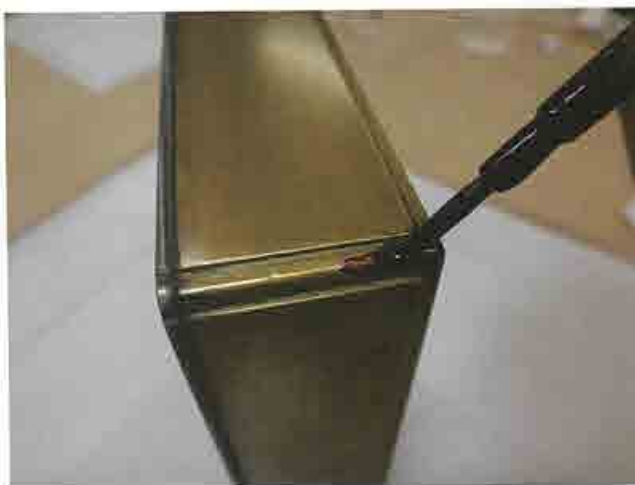
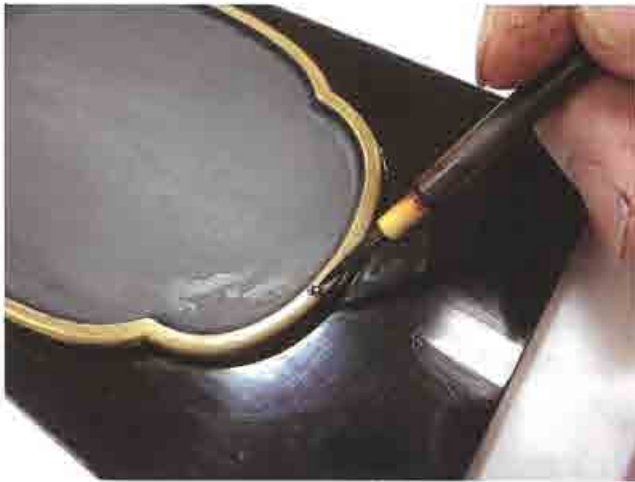
Fig. 1.9.17 蓋裏の亀裂接着
Adhering the crack on the underside of the lid

Fig. 1.9.18 身側板角の亀裂接着
Adhering the crack on the corner of the side
board of the body

Fig. 1.9.19 硯の亀裂接着
Adhering the crack on the inkstone

(15) 亀裂の接着 (Fig. 1.9.17、Fig. 1.9.18、Fig. 1.9.19)

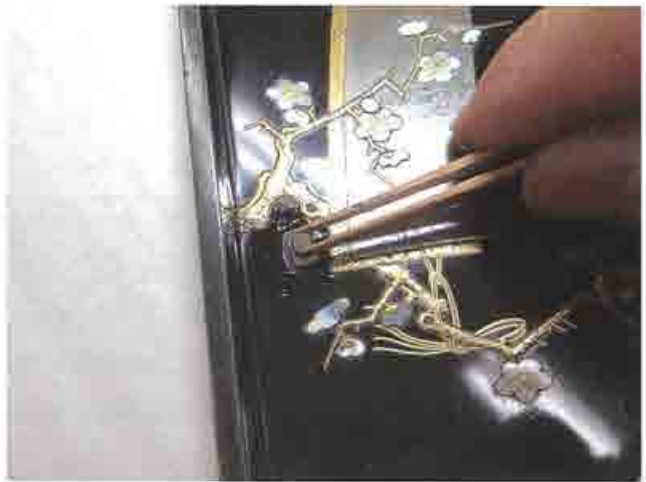
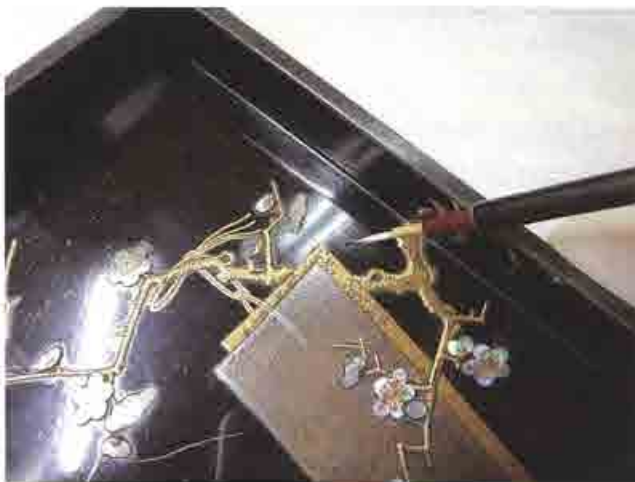
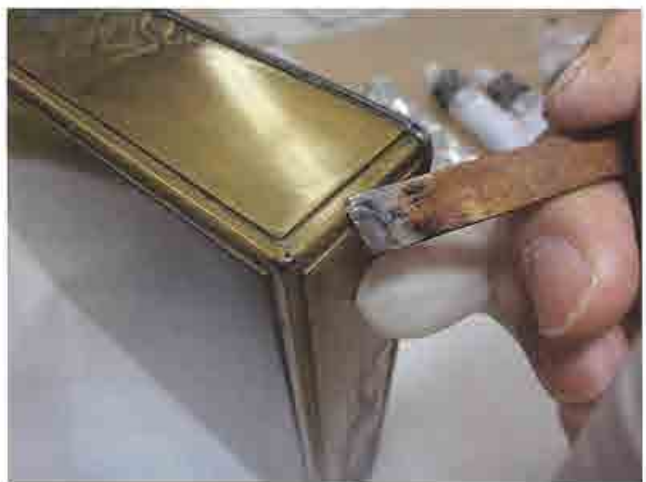
Fig. 1.9.20 色調整 1 懸子打損部の下地研ぎ
Color adjustment 1, polishing the foundation on the damaged part of the inner tray

Fig. 1.9.21 色調整 2 懸子打損部の漆塗り
Color adjustment 2, coating urushi on the part of the inner tray damaged by impact

Fig. 1.9.22 色調整 3 身側板角の金色下地付け
Color adjustment 3, applying gold foundation to the corner of the side boards on the body

(16) 色調整 (Fig. 1.9.20、Fig. 1.9.21、Fig. 1.9.22)

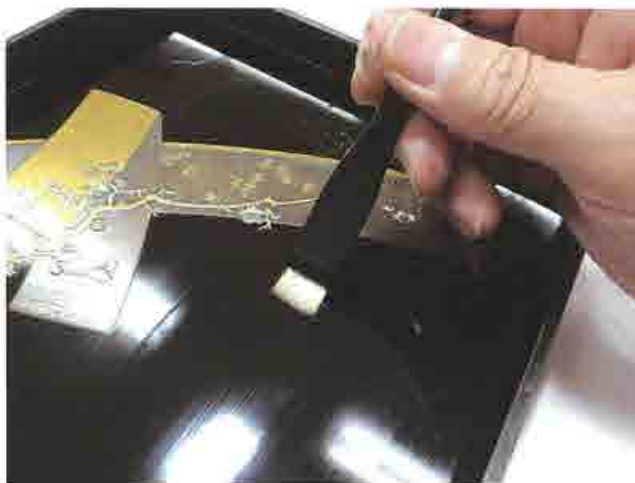
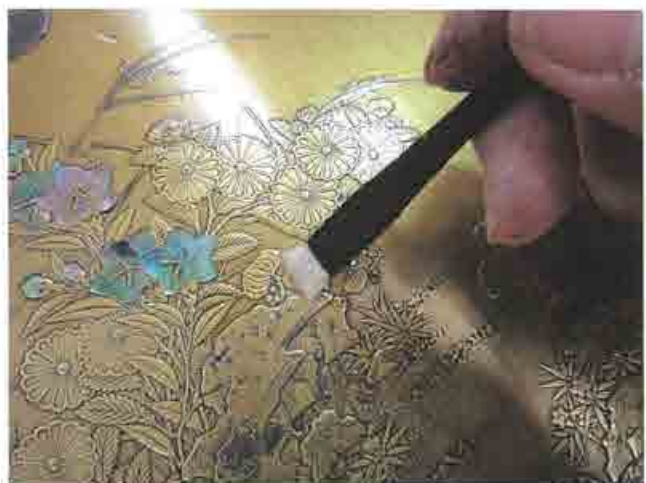
Fig. 1.9.23 漆固め 1 蓋裏の漆塗膜部分
Consolidating urushi 1, part of the urushi coating film on the underside of the lid

Fig. 1.9.24 漆固め 2 蓋表蒔絵部分
Consolidating urushi 2, part of the *maki-e* on the lid

(17) 漆固め (Fig. 1.9.23、Fig. 1.9.24)

漆塗膜部分と蒔絵表面に再度漆固めを行った。硯箱全体の漆塗膜にはクリーンソルGで4倍程度に希釈した生正味漆と透漆を混合した漆を溜み刷毛で塗布し、リグロインで拭き取った。蒔絵表面にはクリーンソルGで4倍程度に希釈した透漆、梨地漆と生正味漆を混合した漆を溜み刷毛で塗布し、リグロインで拭き取った。漆固めは湿度を70%前後に調整した漆風呂で十分に乾燥させた。
